In accordance with our approved October 21, 2014 scope of services document, the Whitman, Requardt & Associates, LLP (WRA) team has prepared this Design Level Inspection Report to present our findings (with repair recommendations and conceptual costs) resulting from the recently completed design level inspection and testing of the specified project bridges, which include the following:

The Wilmington Viaduct consists of Bridges 1-748, 1-748N, and 1-748S and comprises the mainline elevated section of I-95 in downtown Wilmington, Delaware over Amtrak and various City streets. The entire structure is a sixty (60) span steel beam bridge composed entirely of single span units built in 1964 and widened in 1978. Rehabilitation was performed on the viaduct in 2000 that included bearing replacements, seismic retrofits, strip seal replacements, parapet rehabilitation, substructure repairs, drainage repairs, and painting. The viaduct has an overall length of 5462'-0"± measured from centerline of abutment bearings.

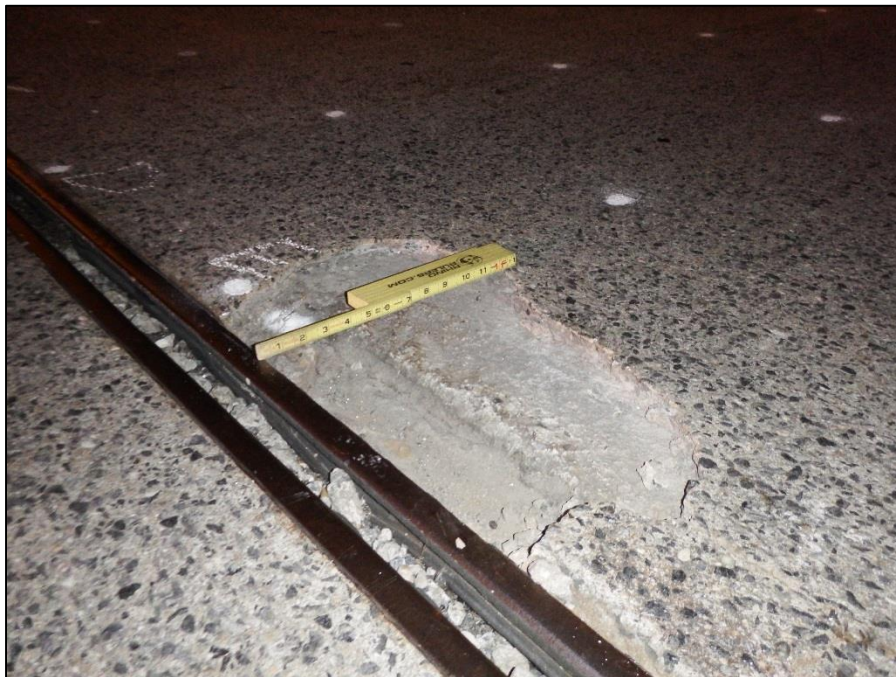
Photo 1: Torn joint seal and corroded armoring (Span 7 Northbound, Pier 6)

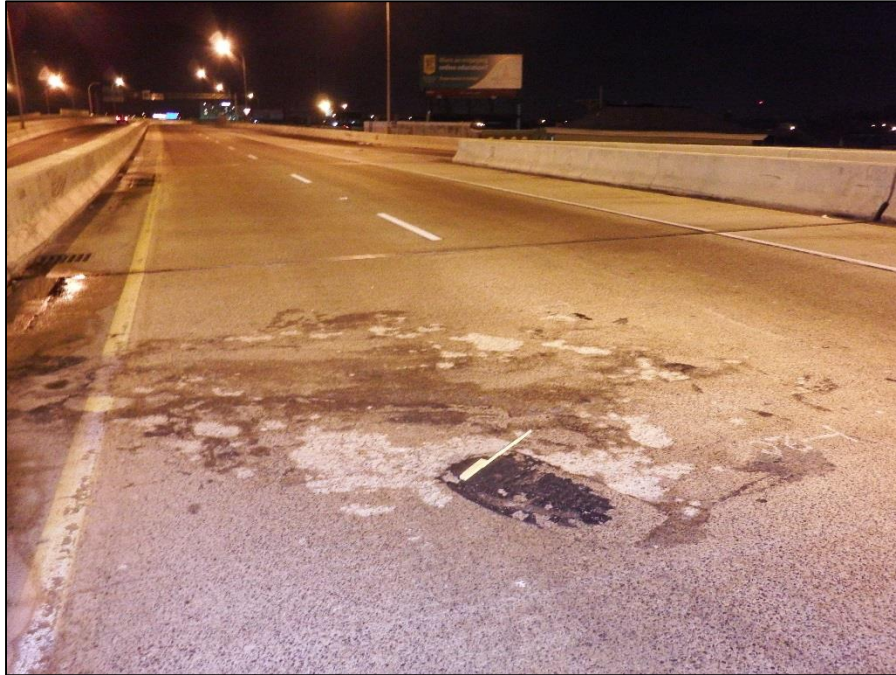
Photo 2: Deck spall at joint (Span 26 Northbound, Pier 26)

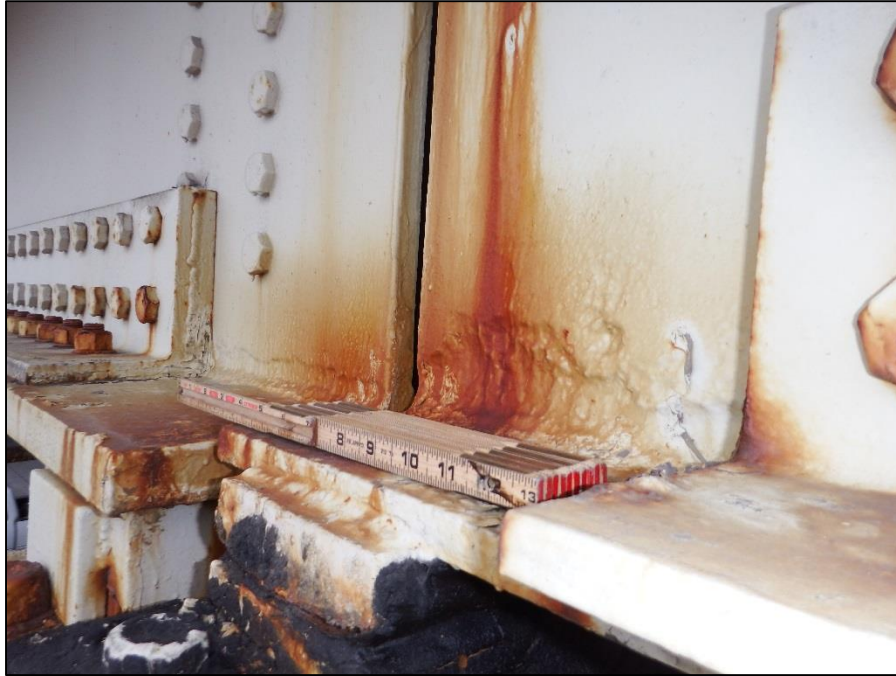
Photo 4: Typical peeling paint with exposed primer (Span 23, Beam 9)

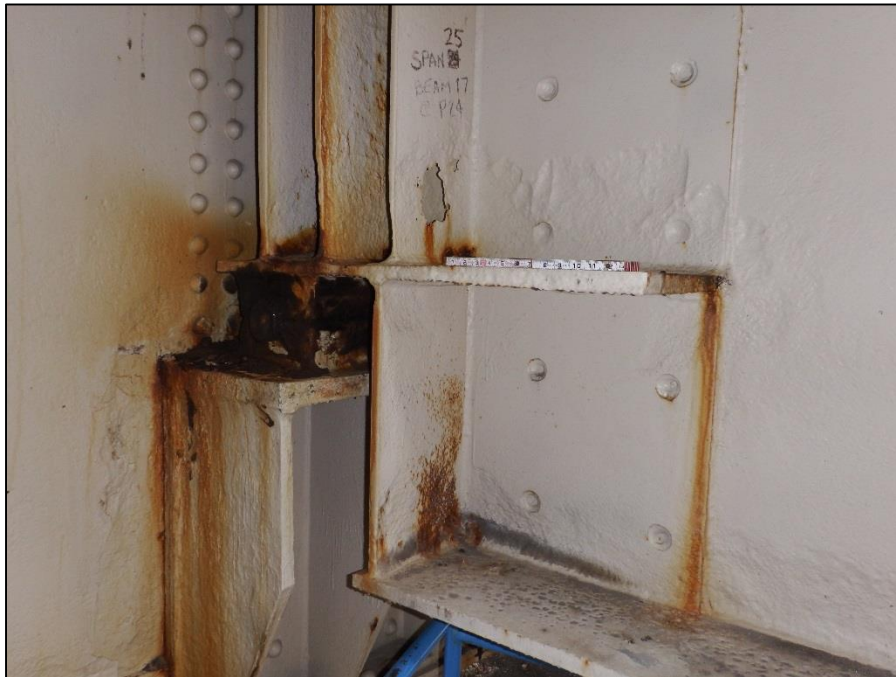
Photo 5: Typical beam end corrosion and pitting (Span 60N, Beam 10 at Pier 59N)

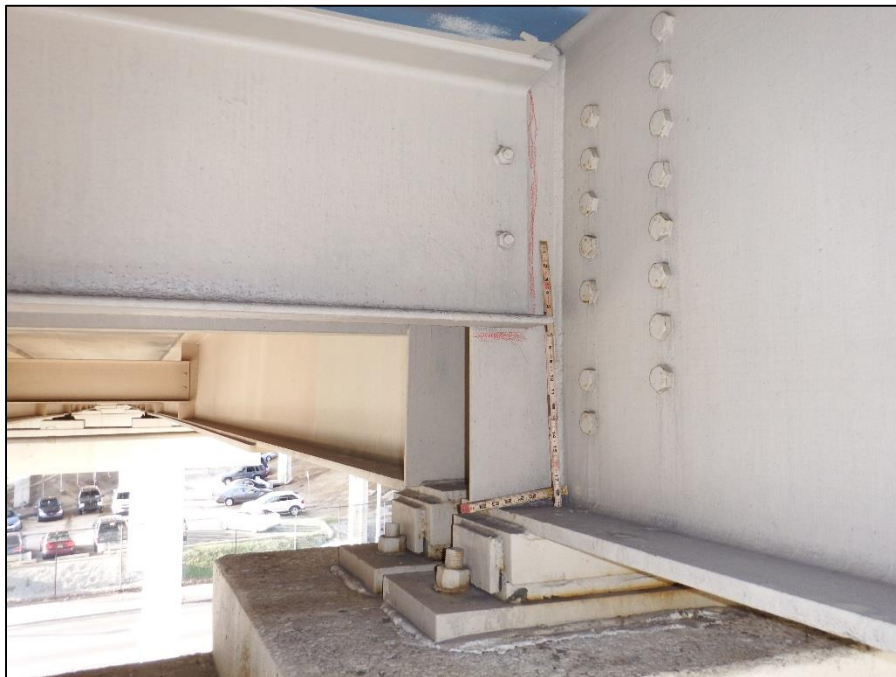
Photo 7: Previous sign structure support to be removed (Span 35N, Beam 6)

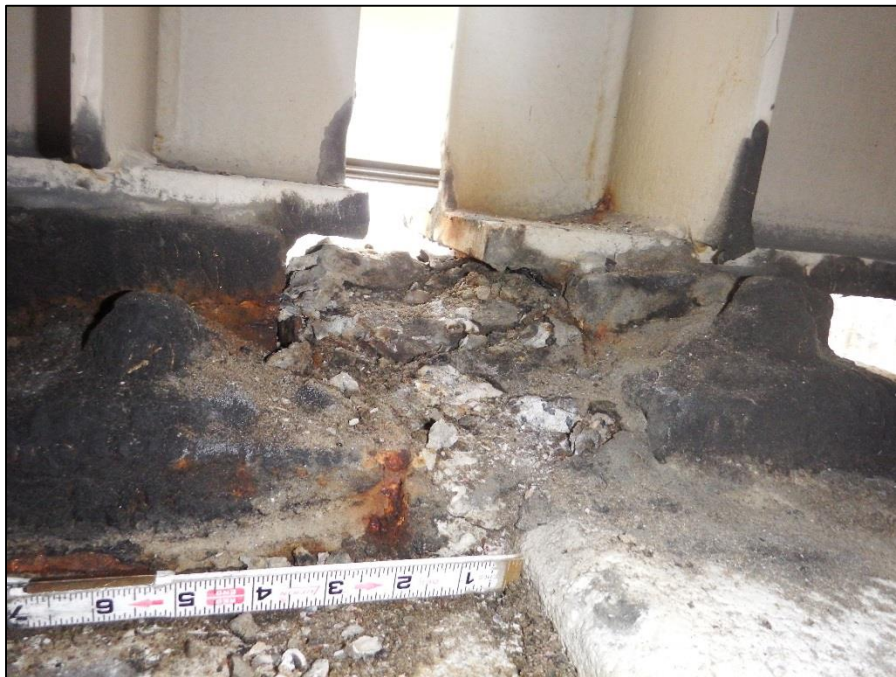
Photo 9: Typical bearing corrosion (Span 9, Pier 8, Bearing 15)

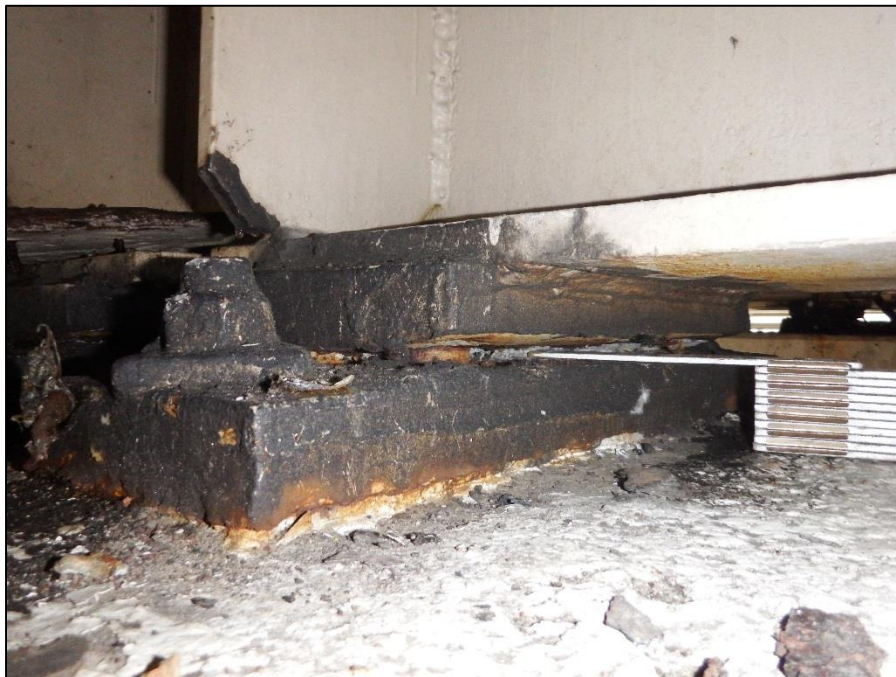
Photo 11: Painted over section loss to anchor bolt nut (Span 52N, Bearing 6)

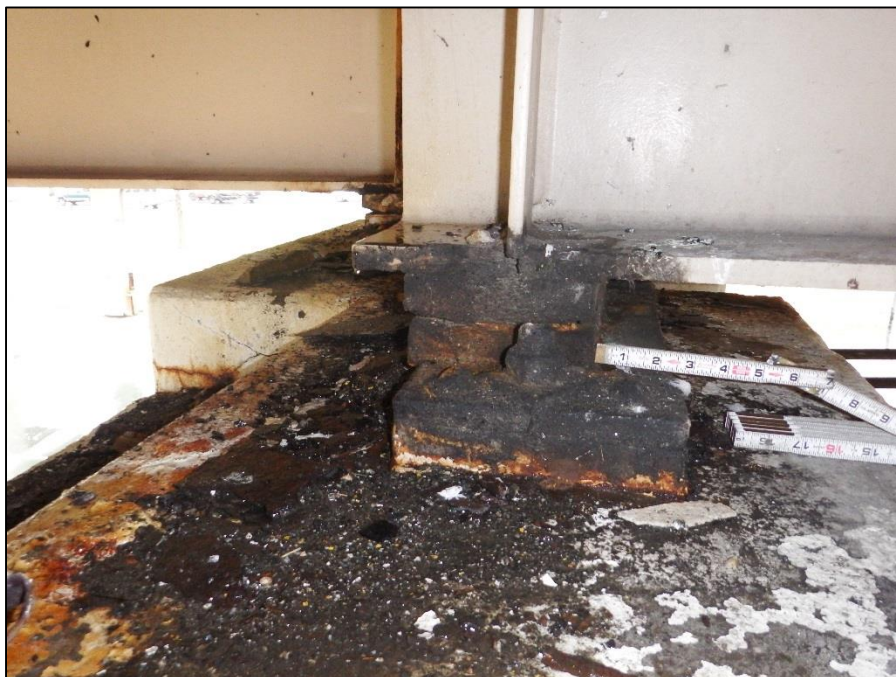
Photo 13: Pack rust between masonry plate and shim plate preventing contraction (Span 54N, Bearing 9 at Pier 53N)

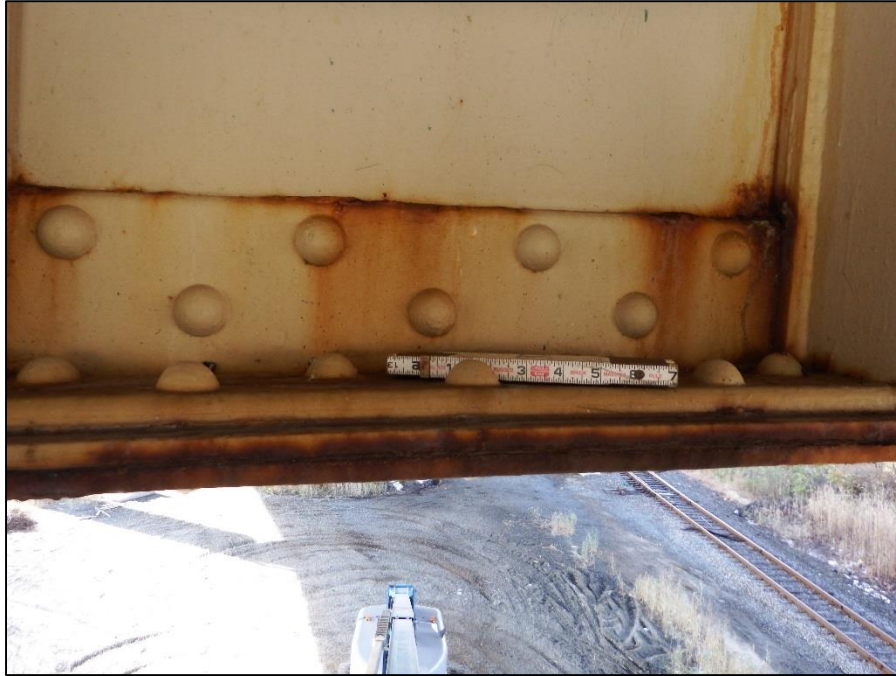
Photo 14: Over expansion (appears to be as-built condition) (Span 54N, Bearing 6)

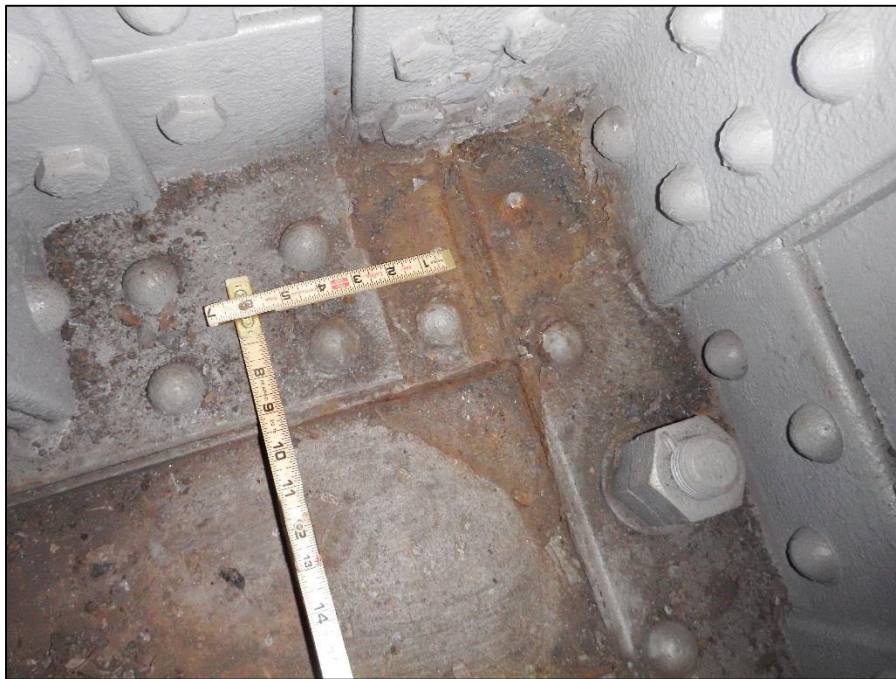
Photo 15: Typical pack rust on bottom flange of built-up pier caps (Pier Cap 11)

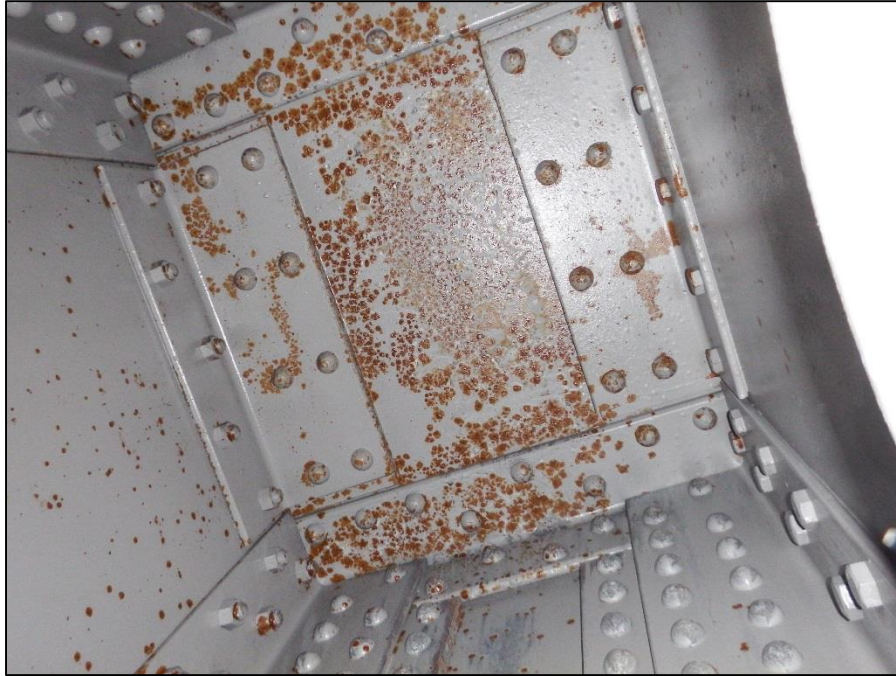
Photo 16: Bottom flange rivet with section loss (Pier Cap 12 interior, east end)

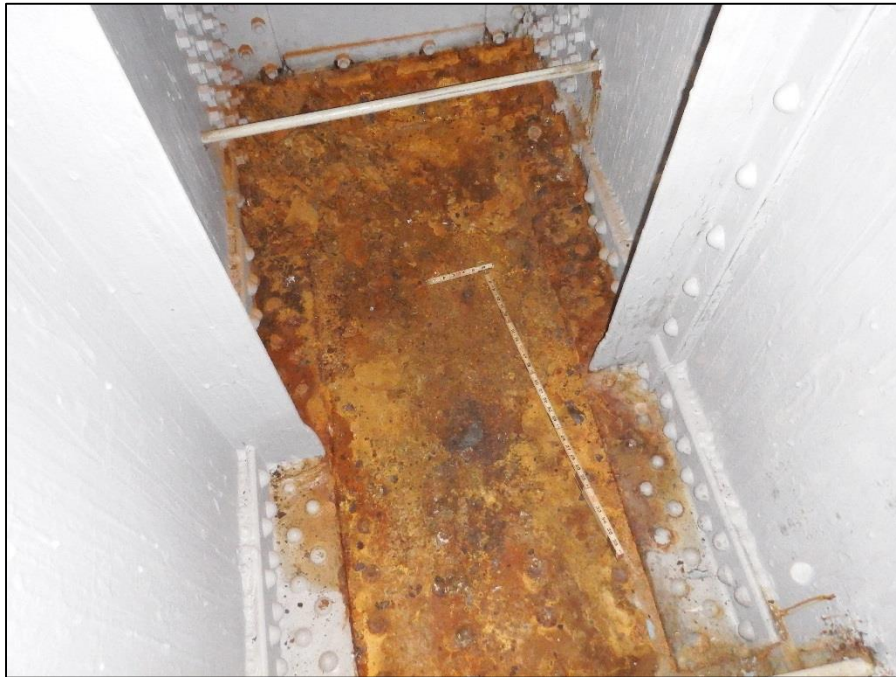
Photo 17: Top flange corrosion (Pier Cap 21 interior, Bay 22)

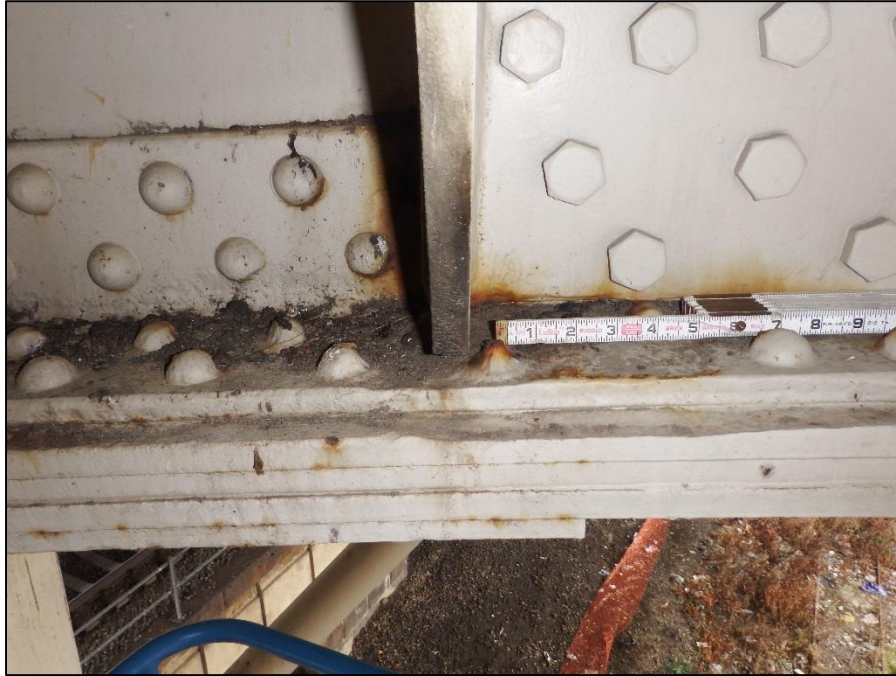
Photo 18: Bottom flange corrosion and rust delaminations from ponding water (Pier Cap 22 interior, Bay 7)

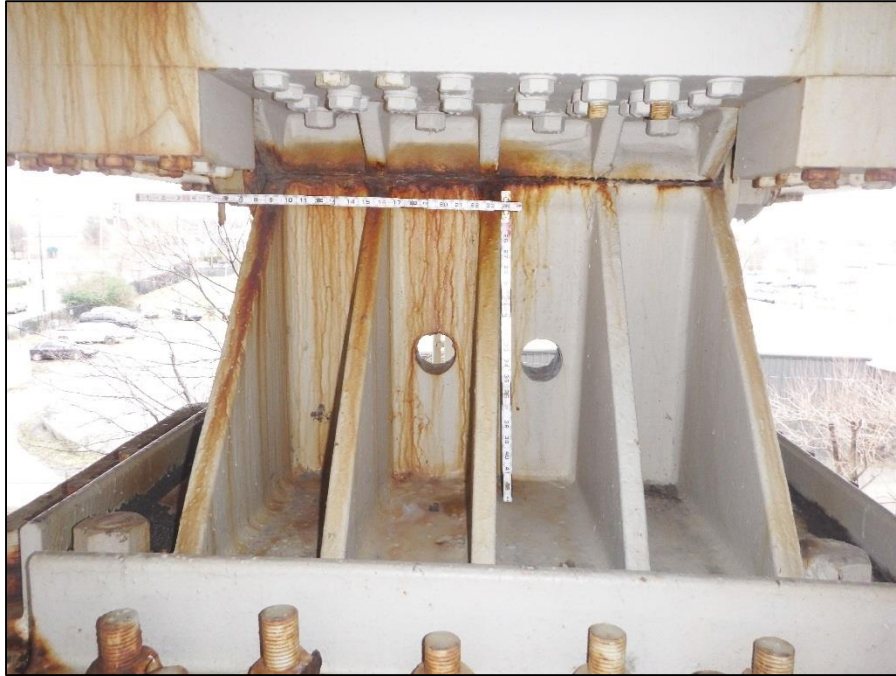
Photo 20: Steel debris (Span 11, Pier Cap 11, Bearing 3)

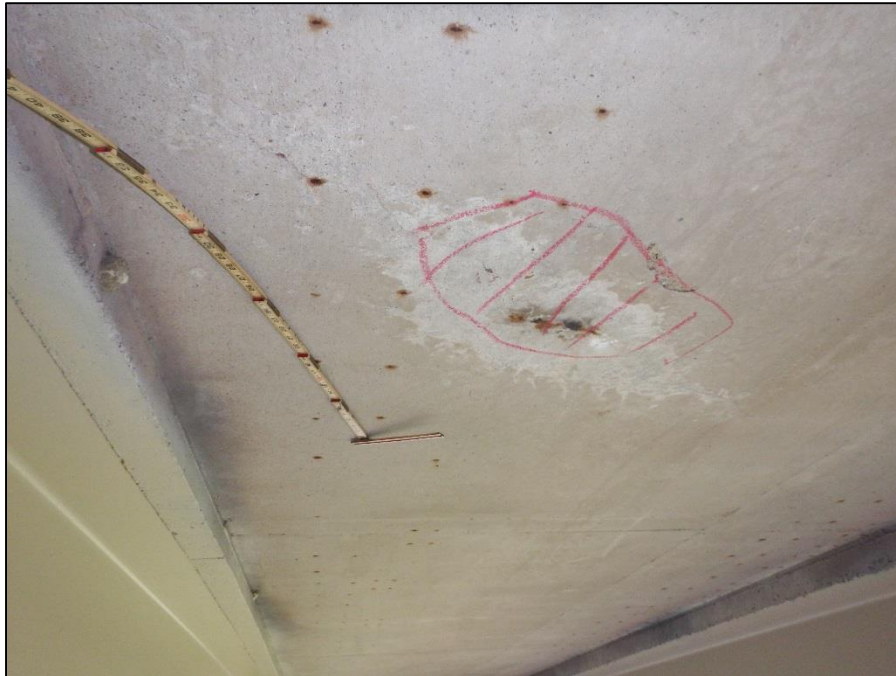
Photo 1: Soffit delamination with efflorescence (Span 4, Bay 3)

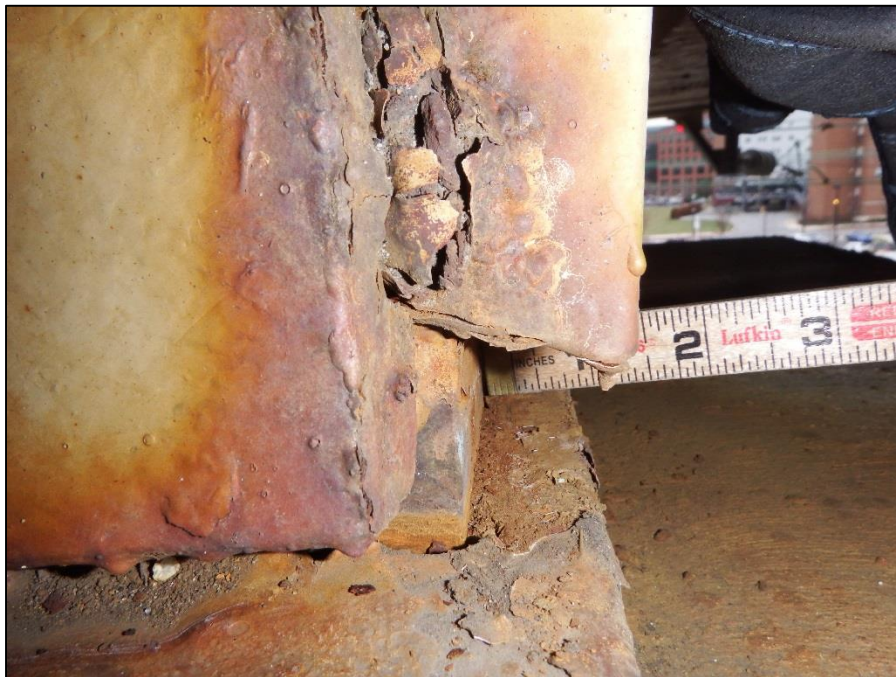
Photo 4: Corroded and fully contracted bearing (Span 2, Bearing 1 at Pier 2)

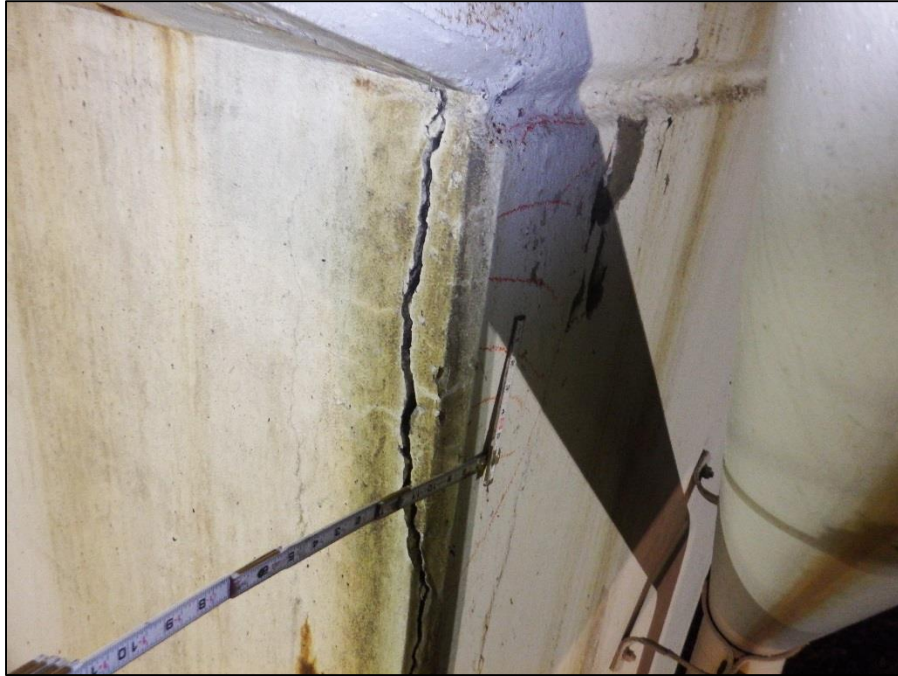
Photo 5: Delamination with associated 2'-6" high x 1/4" wide vertical crack (Pier 1, Southwest Corner)

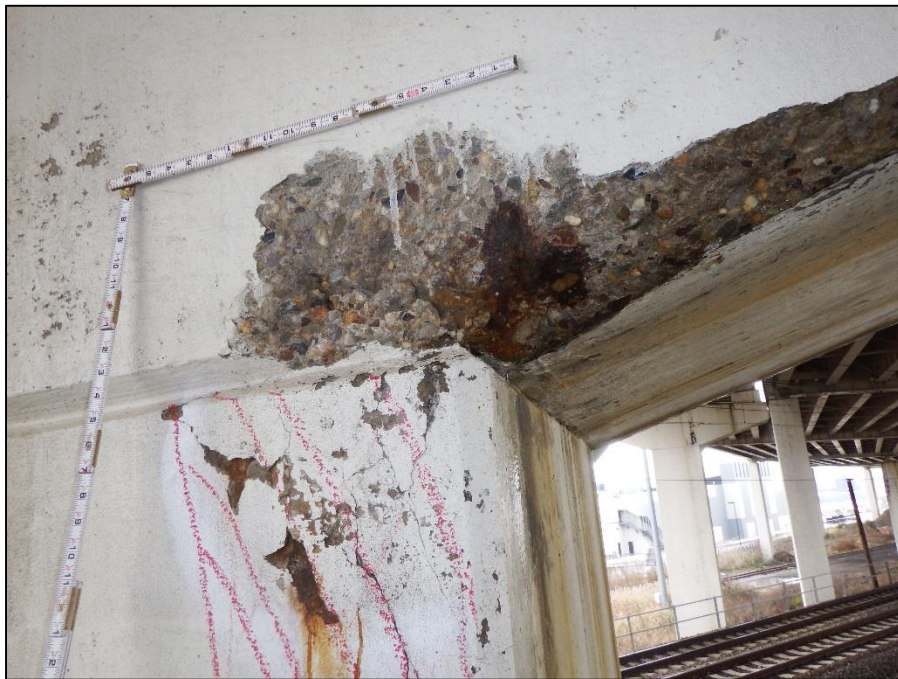
Photo 6: Delamination and spall with exposed corroded steel reinforcement (Pier 2, North Face)

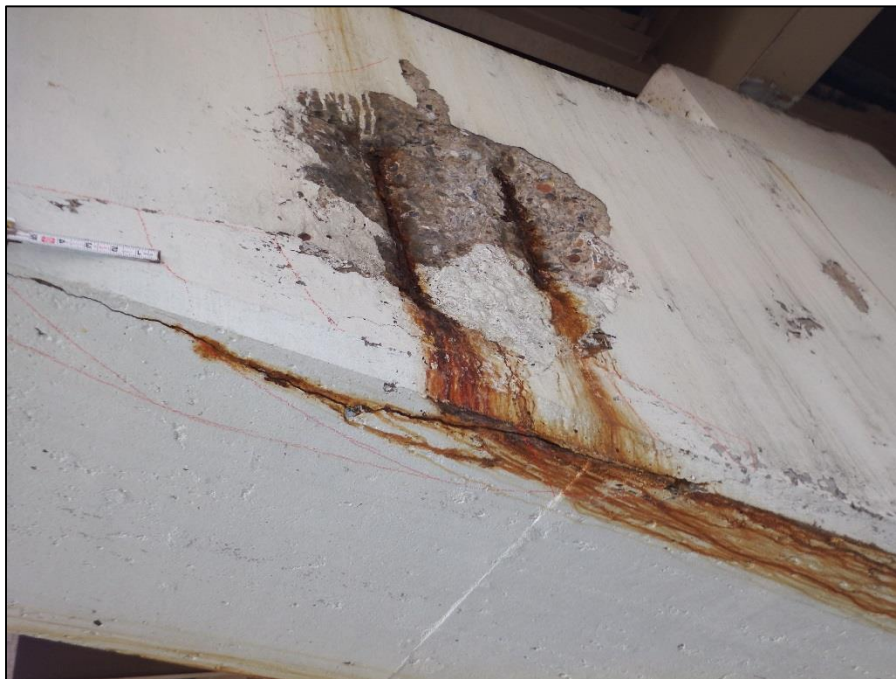
Photo 2: Spall with exposed corroded steel reinforcement (Span 2, Pier 2)

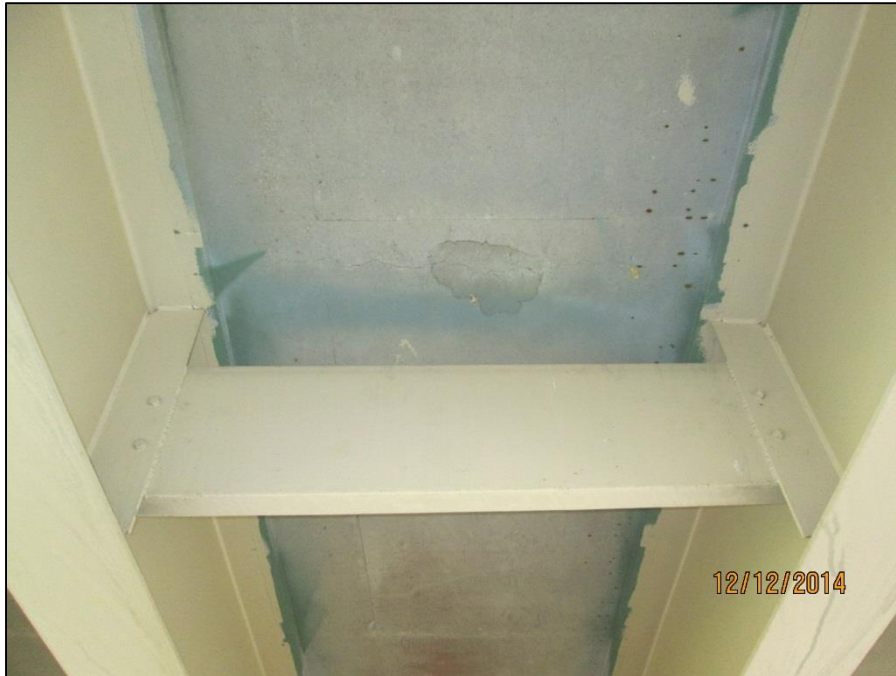
Photo 1: Soffit delamination (Span 2, Bay 2)

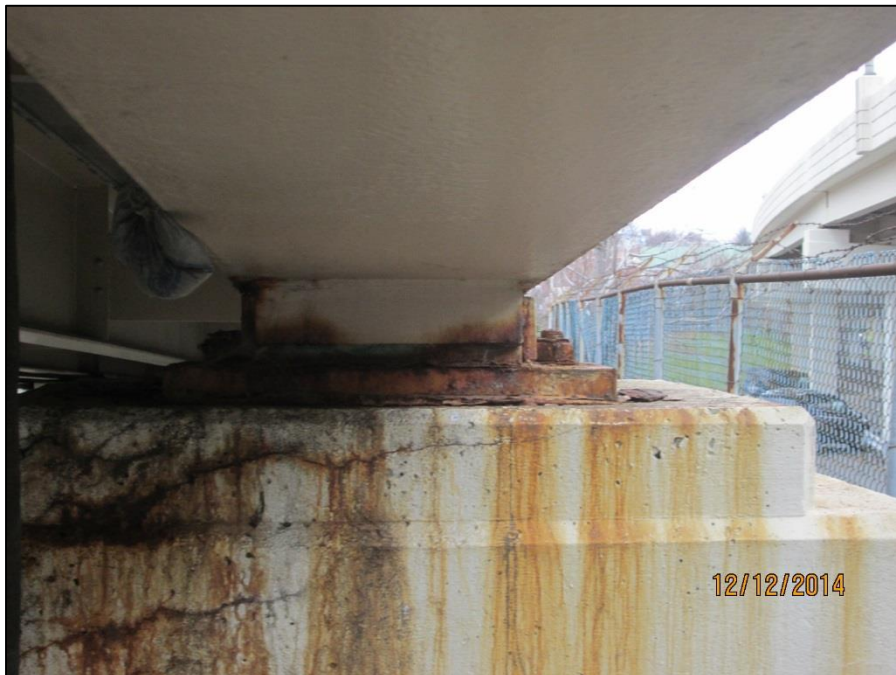
Photo 2: Typical corrosion, rust delaminations, pack rust (Span 3, Bearing 1 at Pier 3)

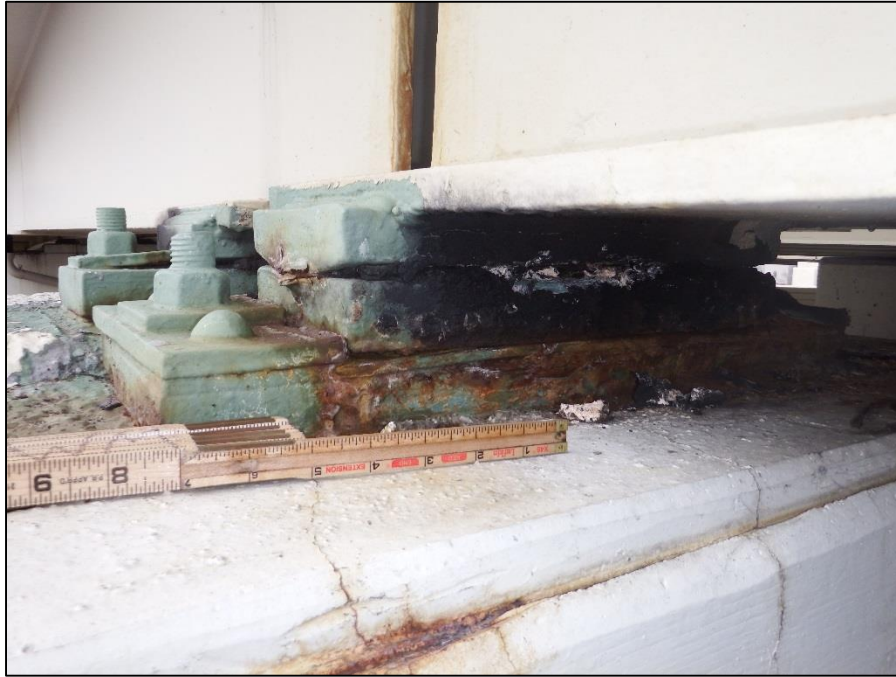
Photo 3: Pack rust preventing movement (Span 6, Bearing 4)

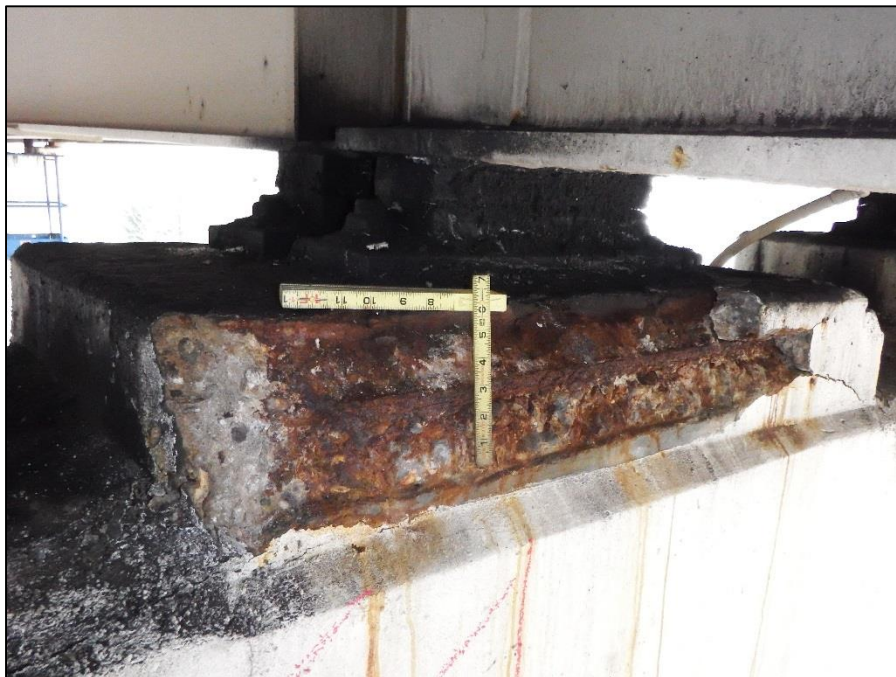
Photo 4: Typical spall with exposed corroded steel reinforcement (Pier 4, Pedestal 2)

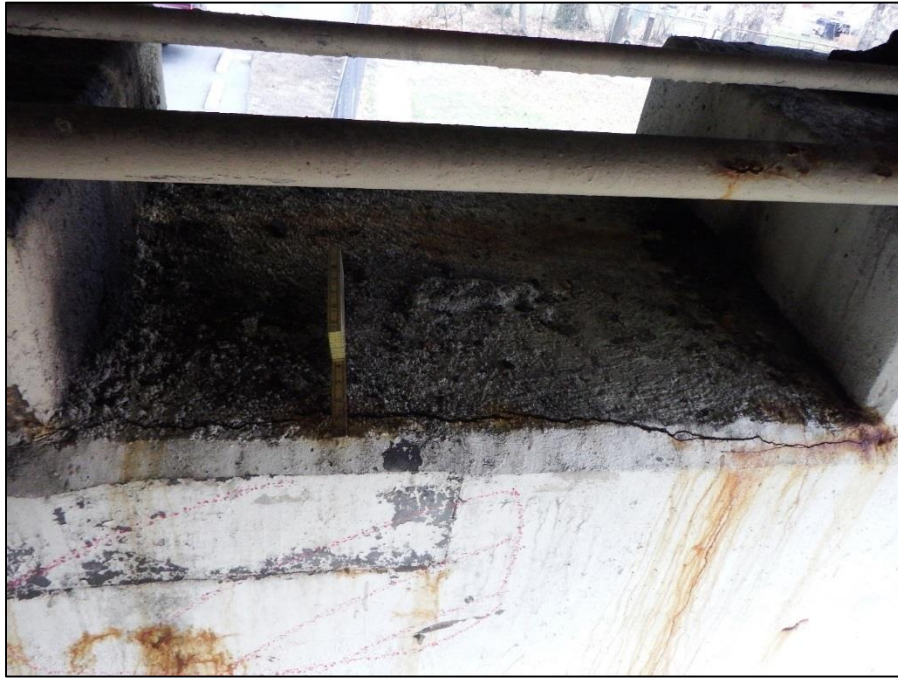
Photo 5: Typical crack and area of delaminated concrete in top of pier cap (Pier 4, Bay 3)

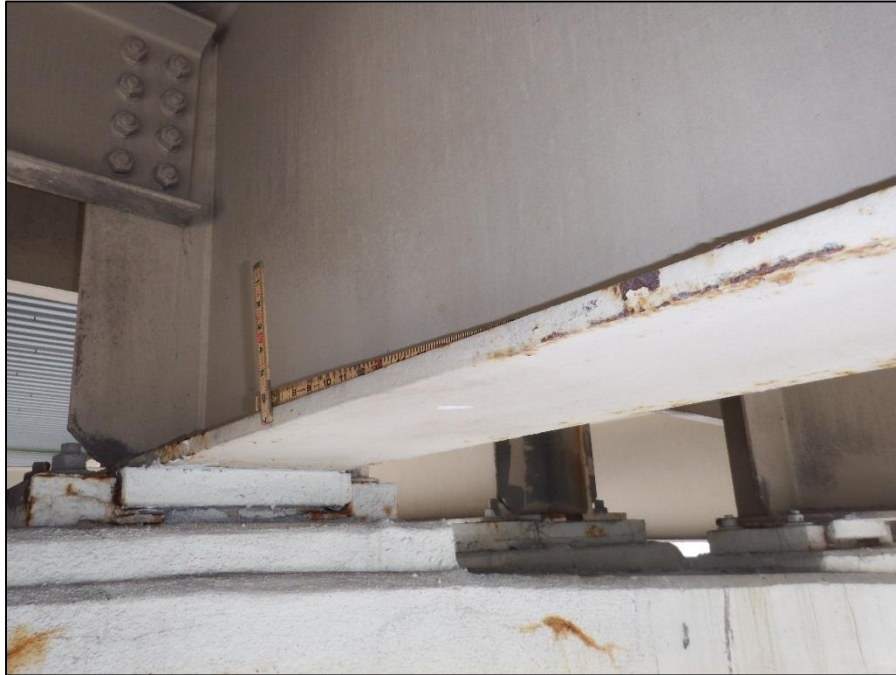
Photo 1: Typical light corrosion at bottom flange near beam end (Span 1, Beam 3 at Pier 11)

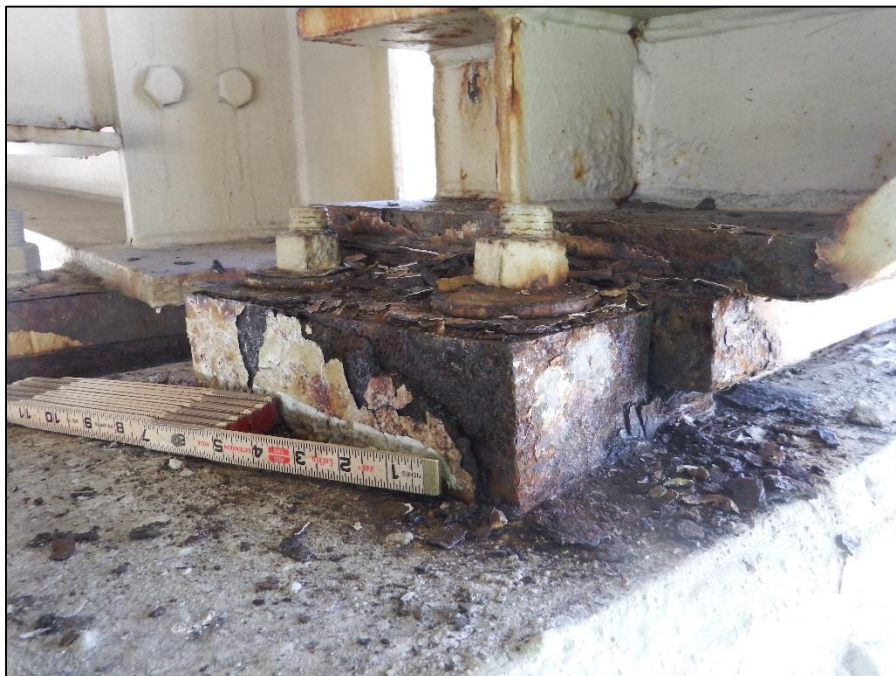
Photo 4: Typical bearing corrosion and rust delaminations (Span 3, Beam 4 at Pier 9)

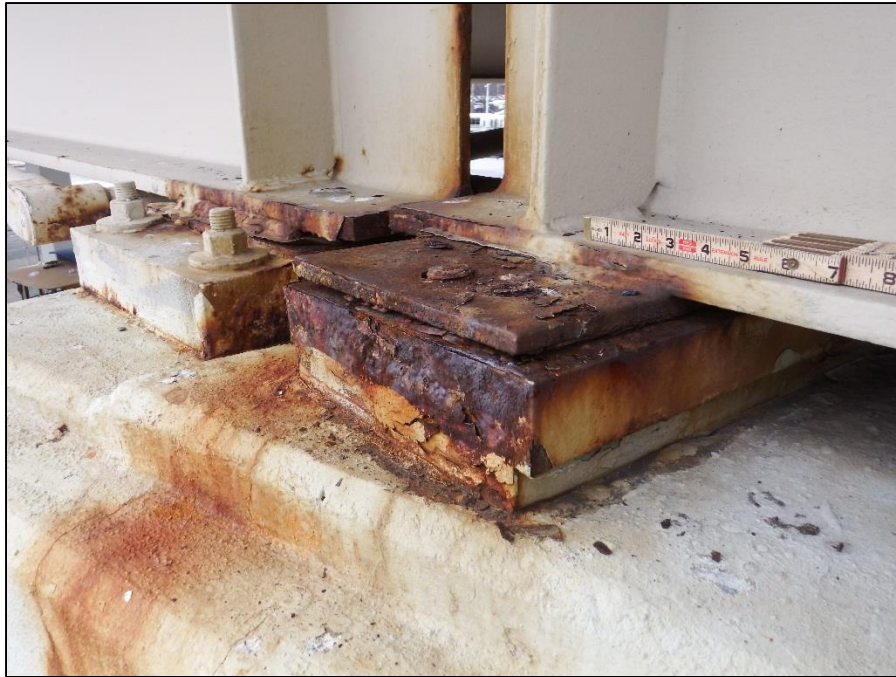
Photo 5: North anchor bolt sheared off (Span 1, Bearing 5 at Pier 12)

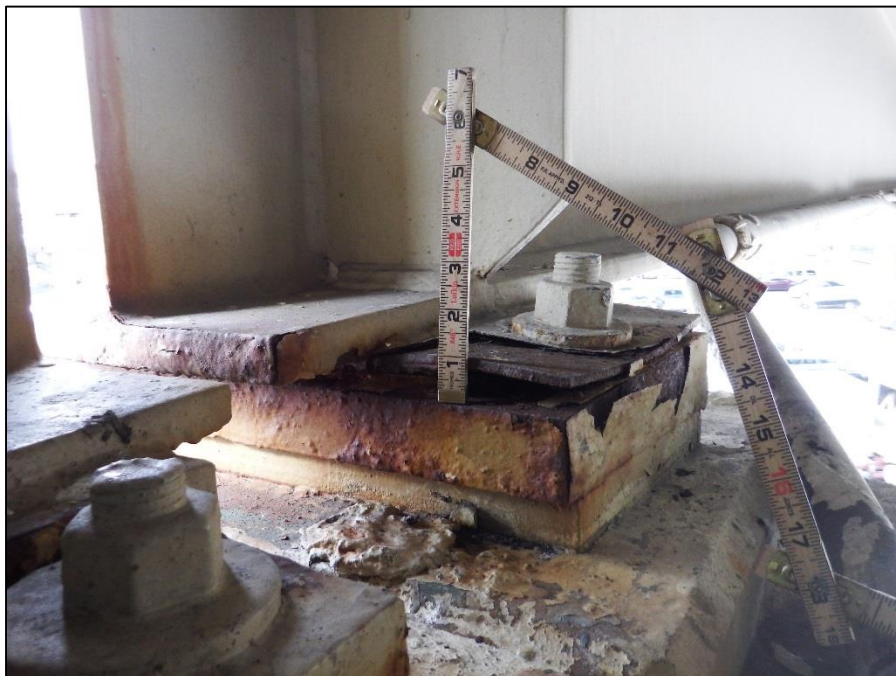
Photo 6: Pack rust between sole and fill plate, deforming fill plate (Span 3, Bearing 1 at Pier 10)

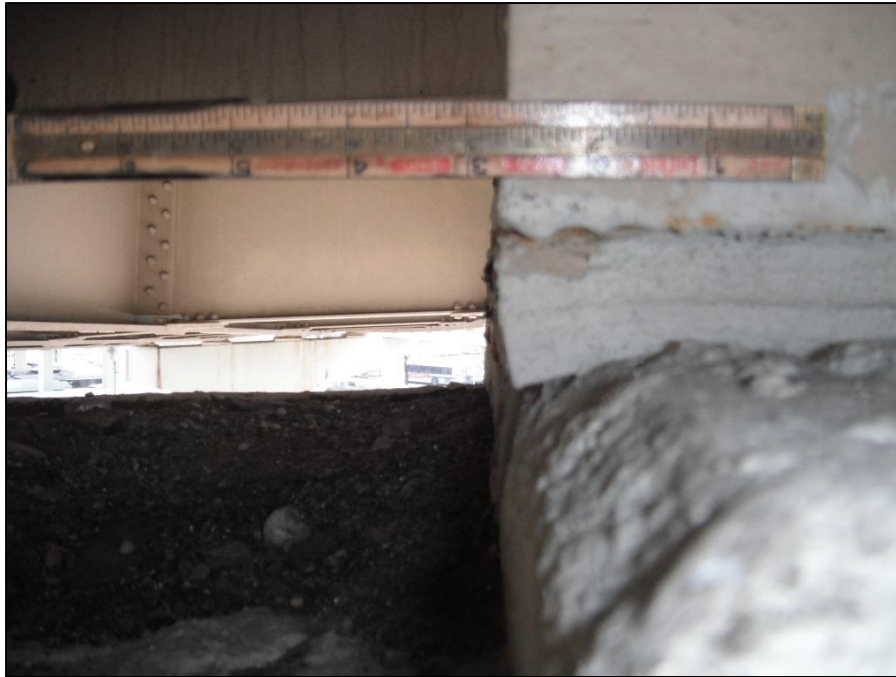
Photo 7: Masonry plate overhanging pedestal 3/4-inches (Span 5, Bearing 1 at Pier 8)

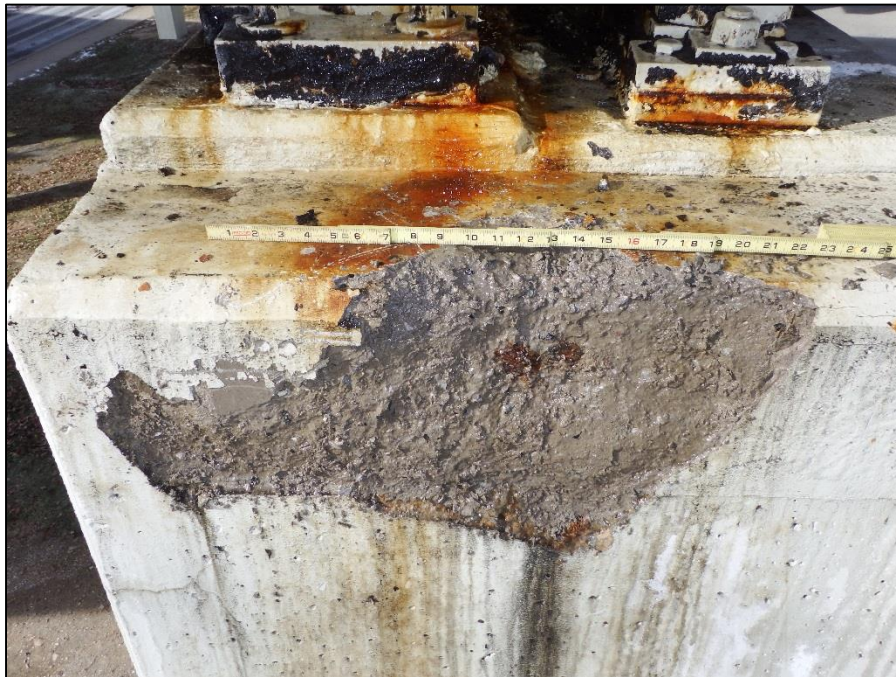
Photo 8: Spall with exposed corroded steel reinforcement (Pier 6, East Face)

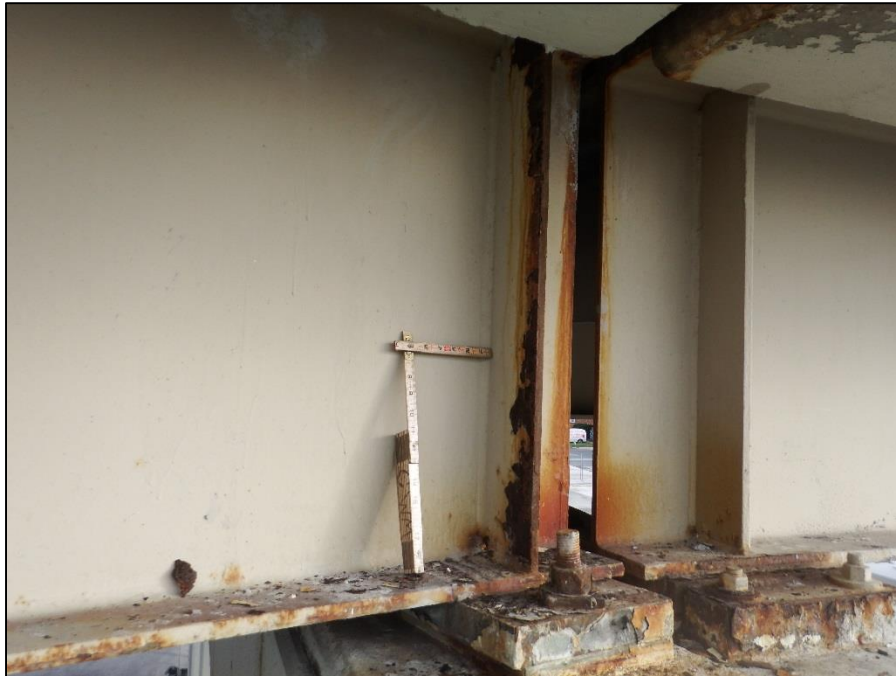
Photo 1: Typical beam end corrosion (Span 4, Beam 5 at Pier 4)

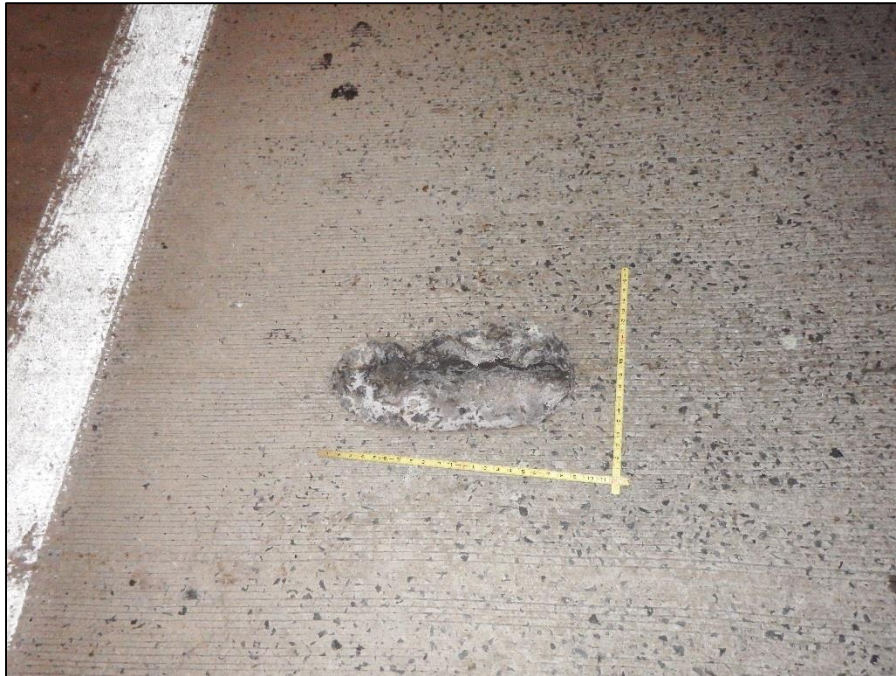
Photo 1: Spall in deck with exposed corroded steel (Span 5, 2/3 span)

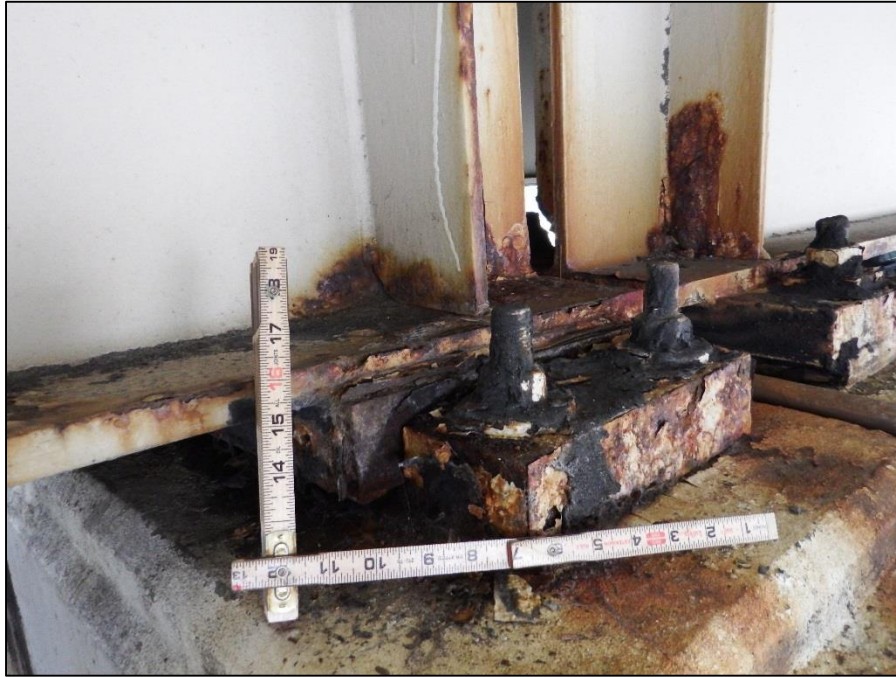
Photo 3: Typical bearing corrosion and anchor bolt nut section loss (Span 8, Bearing 4 at Pier 8)

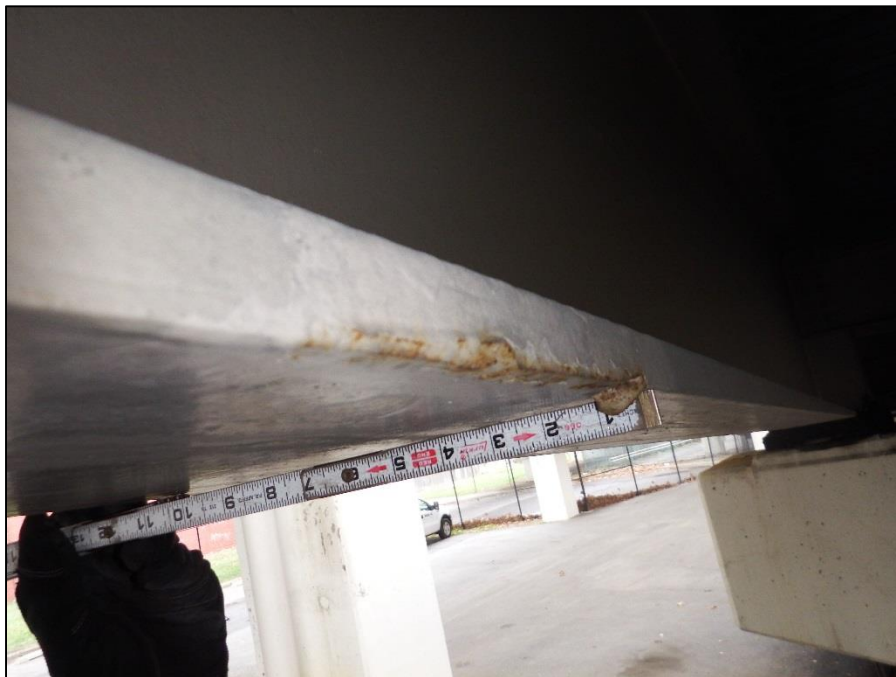
Photo 4: Bottom flange gouge with curled steel (Span 9, Beam 1)

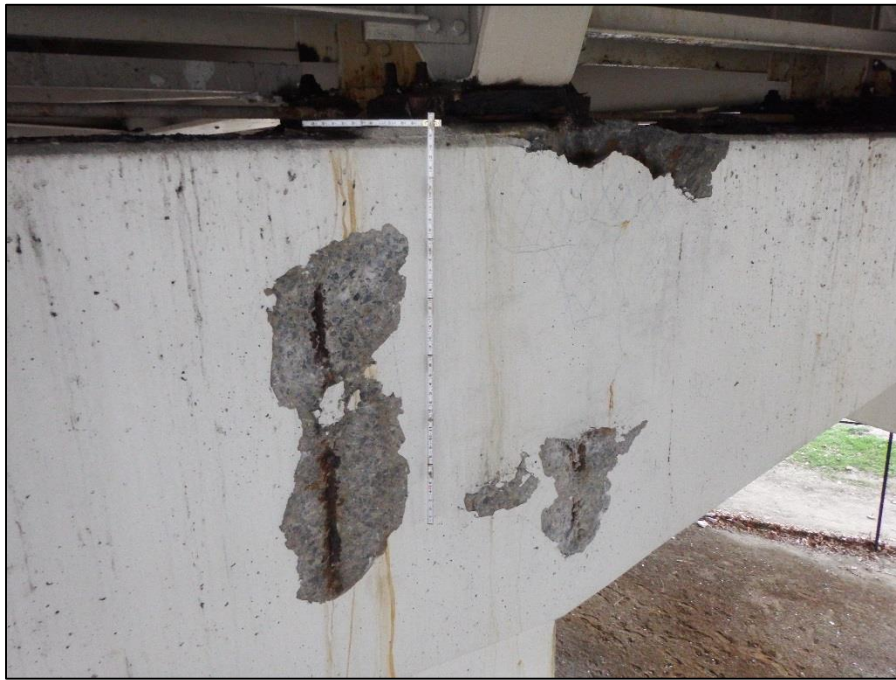
Photo 5: Spalls with exposed corroded steel reinforcement (South face of Pier 6)

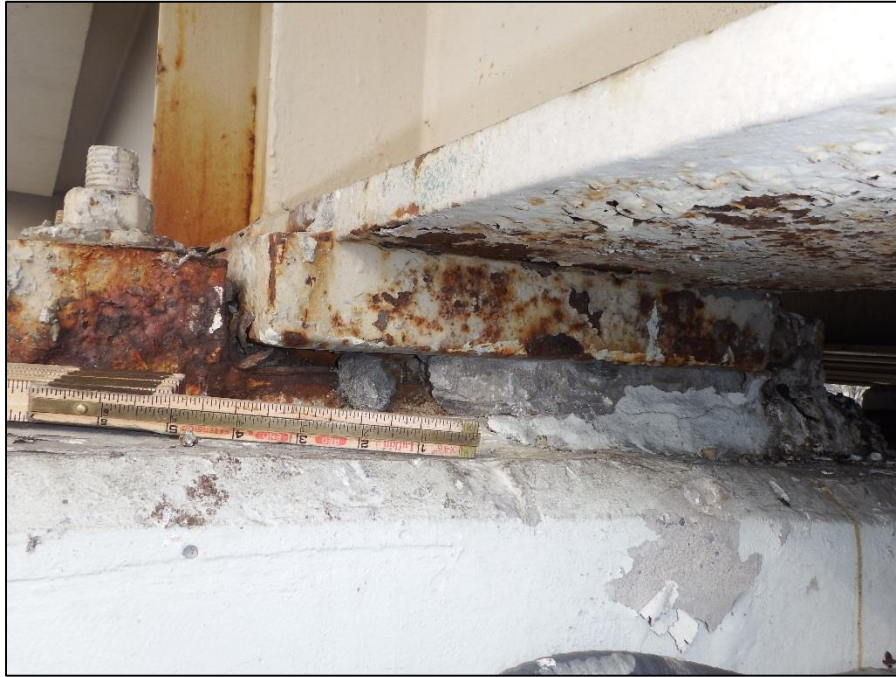
Photo 3: Concrete restricting proper movement (Span 3, Bearing 6 at Pier 3)
